# PRESIDENTIAL COMMISSION

*on the Space Shuttle  
Challenger Accident*

Presidential Commission  
on the  
Space Shuttle Challenger Accident

June 6, 1986

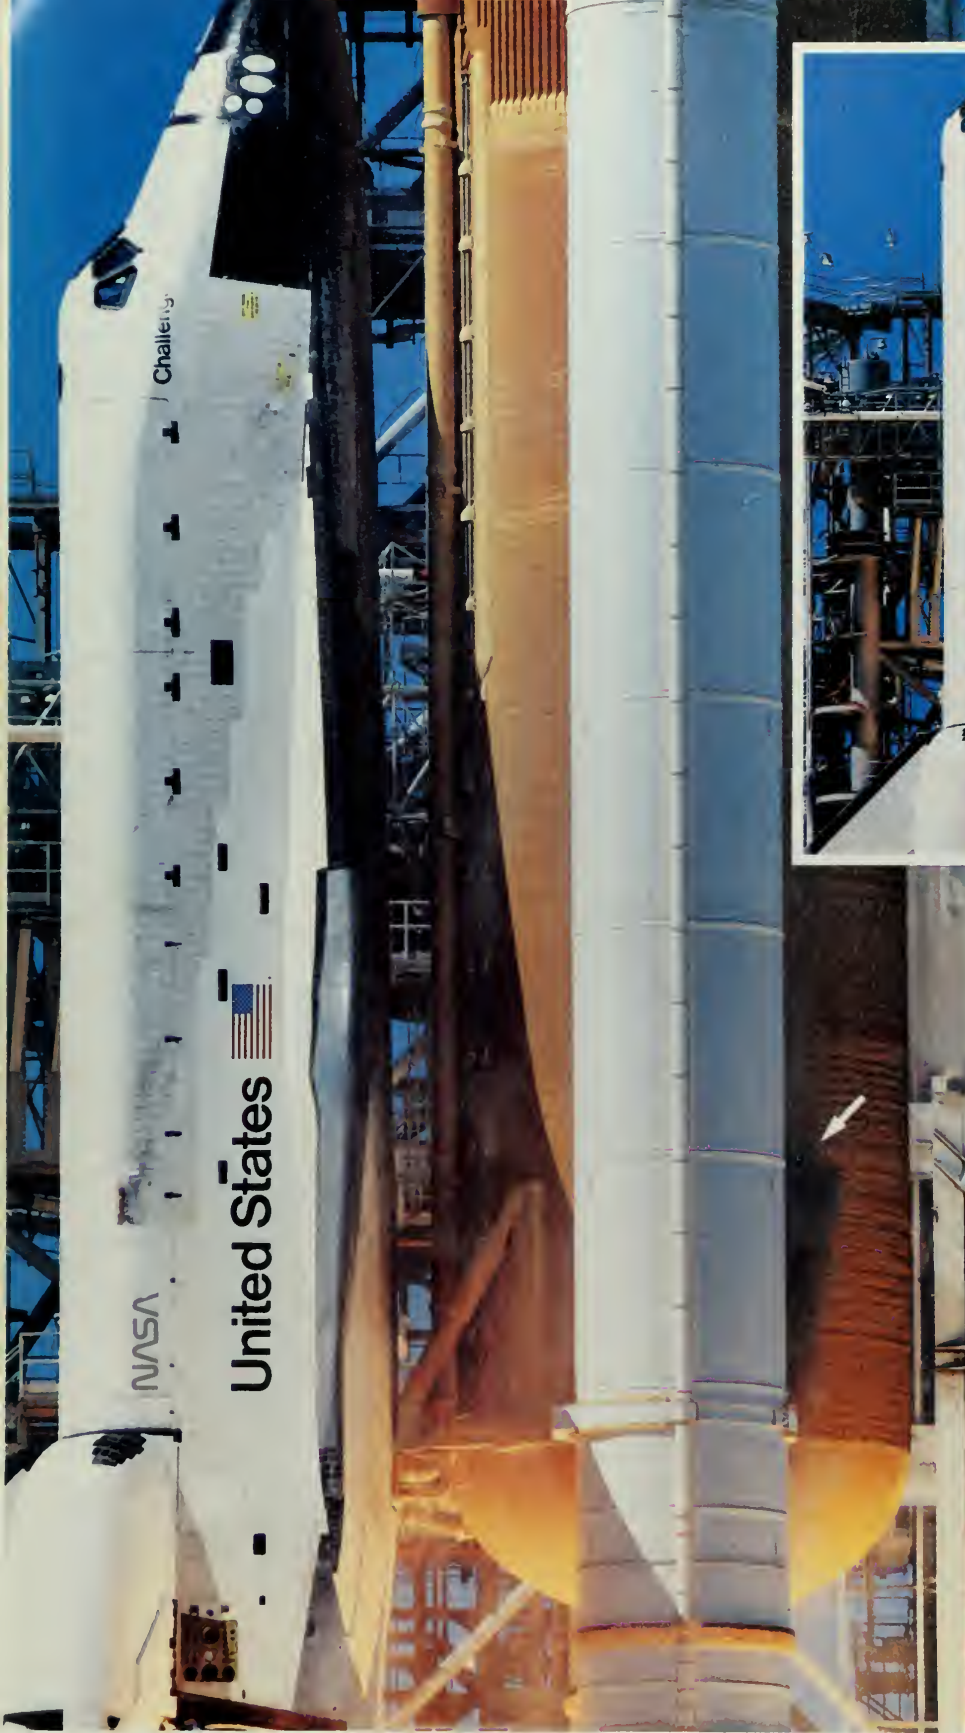
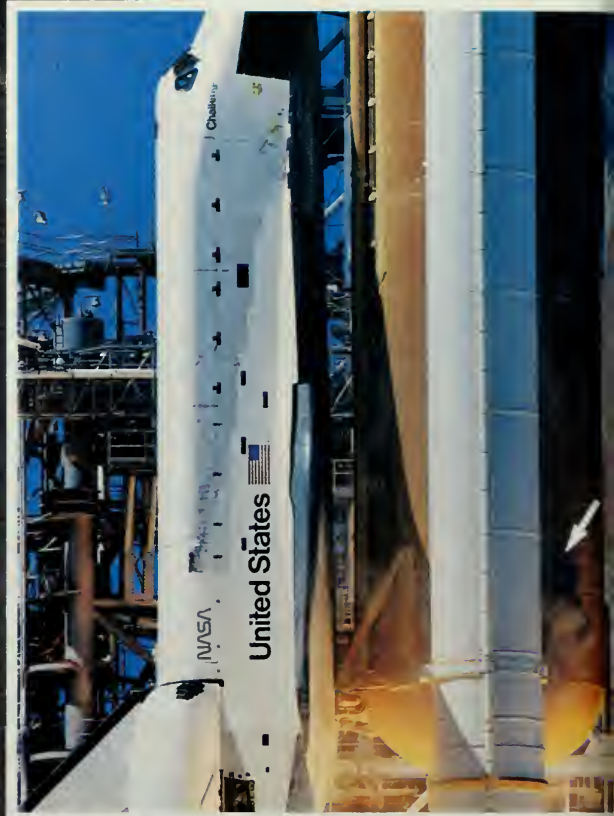
Immediately after solid rocket motor ignition, dark smoke (arrows) swirled out between the right hand booster and the External Tank. The smoke's origin, behavior and duration was approximated by visual analysis and computer enhancement of film from five camera locations. Consensus: smoke was first discernible at .678 seconds Mission Elapsed Time in the vicinity of the right booster's aft field joint.

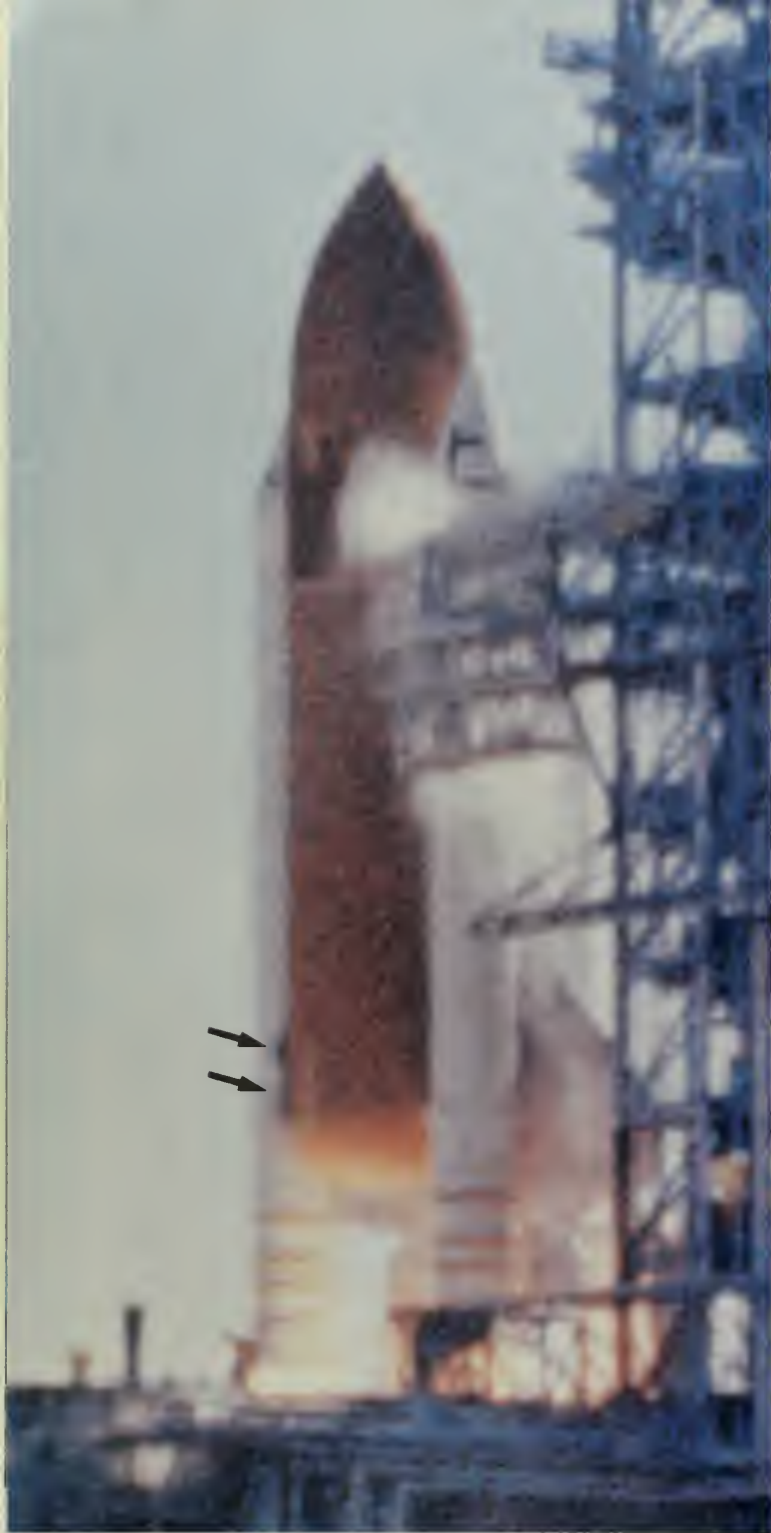
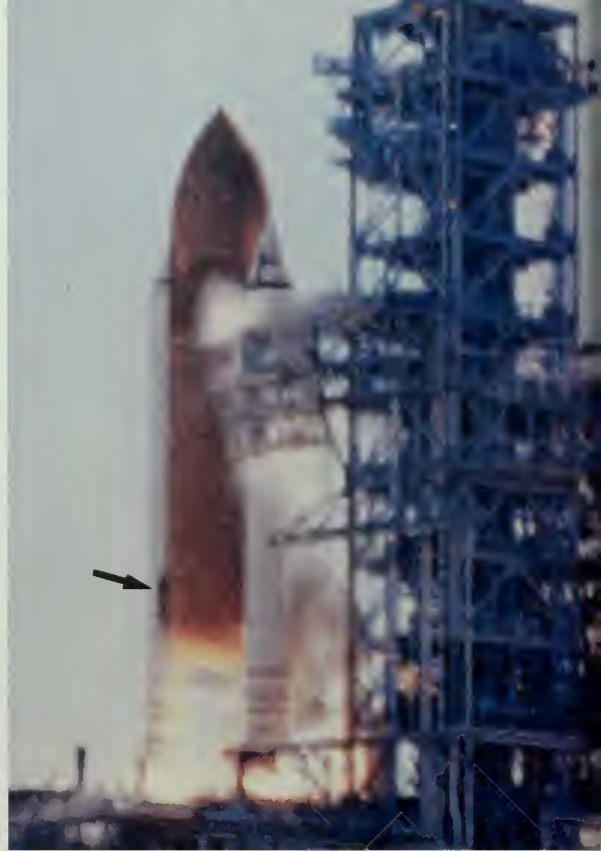
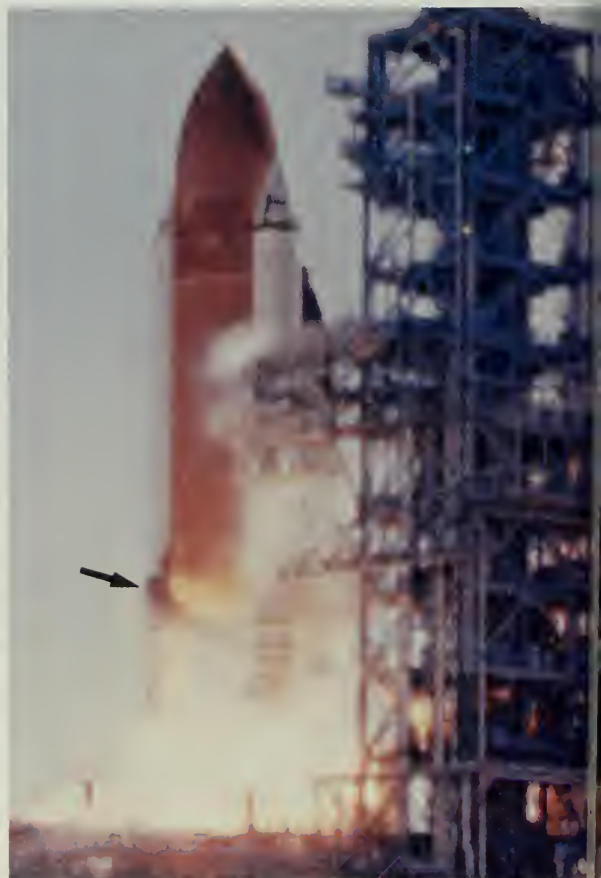
Multiple smoke puffs are visible in the photo above (arrows). They began at .836 seconds and continued through 2.500 seconds, occurring about 4 times a second. Upward motion of the vehicle caused the smoke to drift downward and blur into a single cloud. Smoke source is shown in the computer generated drawing (far right).

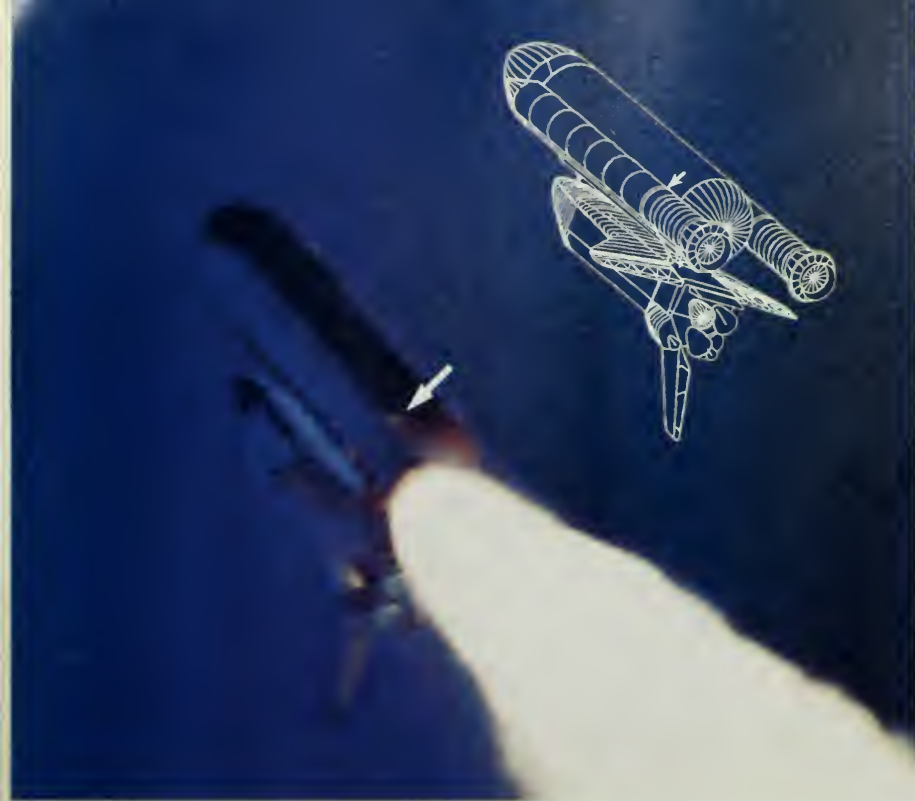
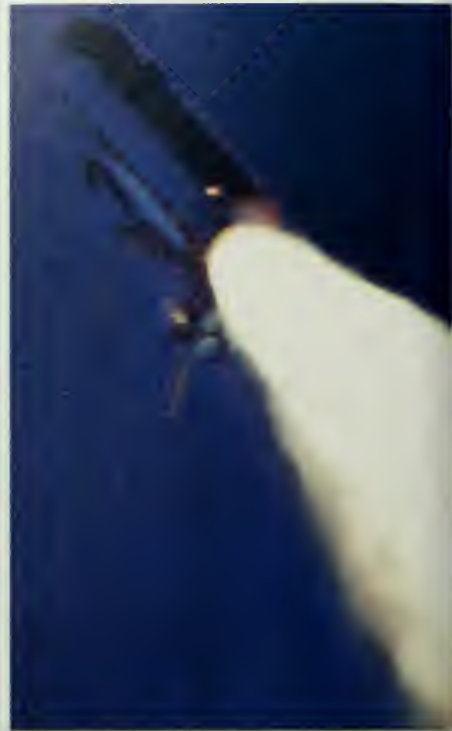
At 58.788 seconds, the first flicker of flame appeared. Barely visible above, it grew into a large plume and began to impinge on the External Tank at about 60 seconds. Flame is pinpointed in the computer drawing between the right booster and the tank, as in the case of earlier smoke puffs. At far right (arrow), vapor is seen escaping from the apparently breached External Tank.

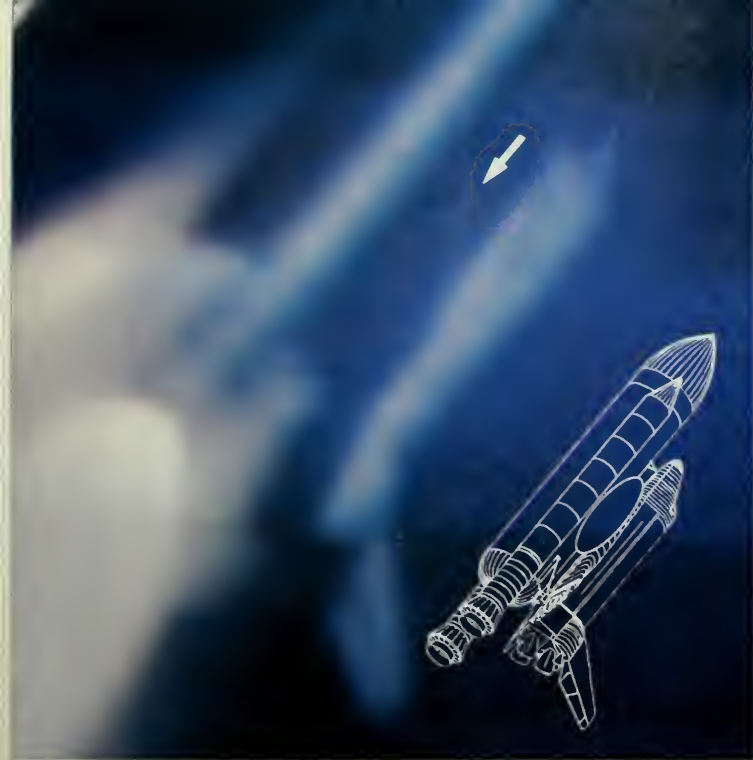
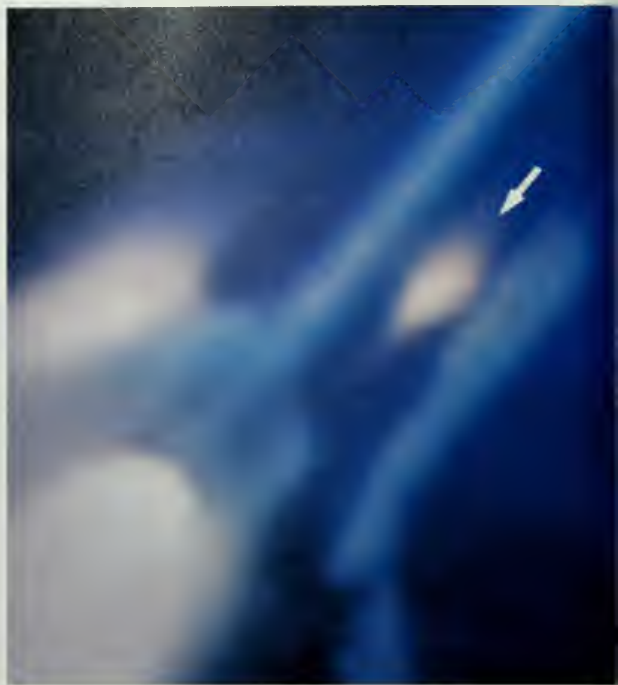
Camera views indicate the beginning of rupture of the liquid hydrogen and liquid oxygen tanks within the External Tank. A small flash (arrows above) intensified rapidly, then diminished. A second flash,

attributed to rupture of the liquid oxygen tank, occurred above the booster/tank forward attachment (below left) and grew in milliseconds to the maximum size indicated in the computer drawing.

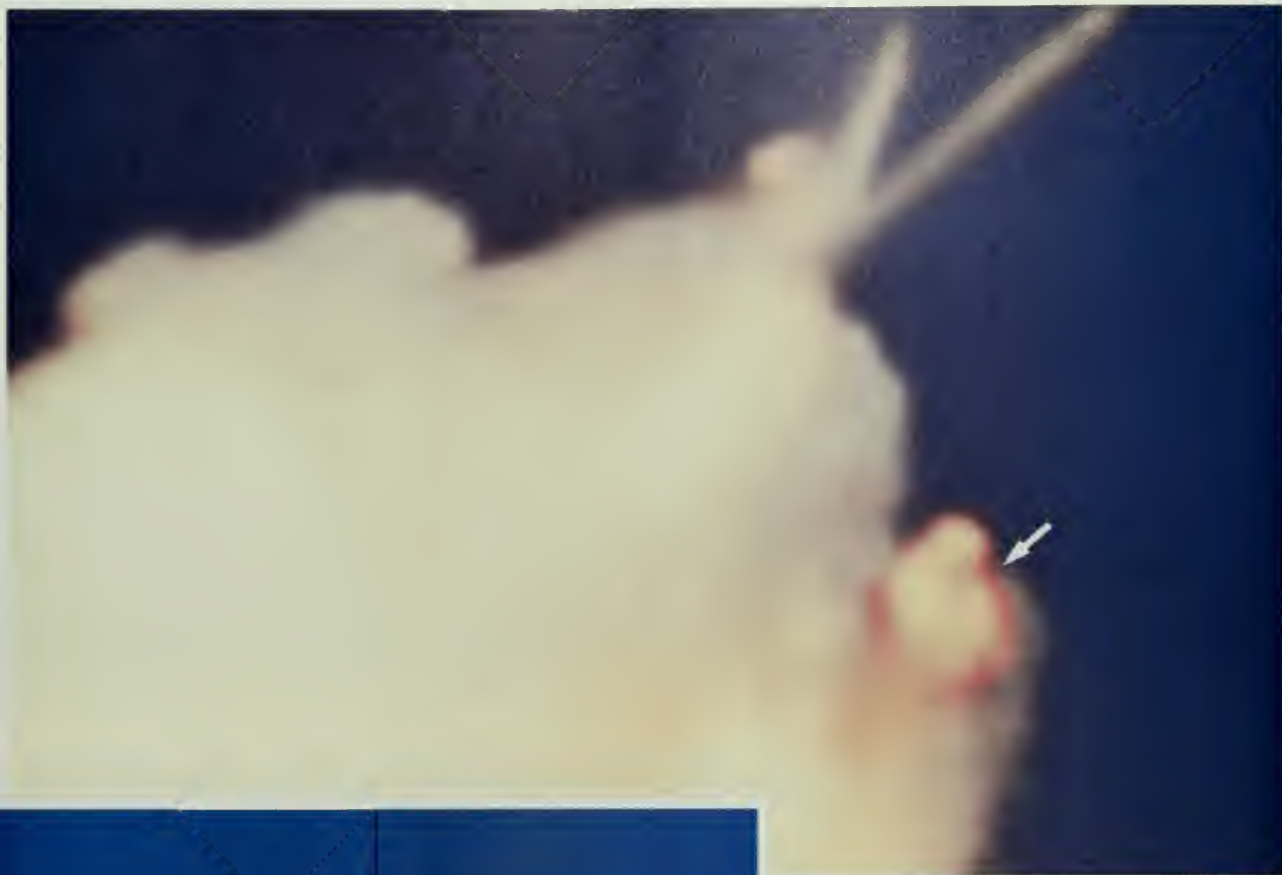
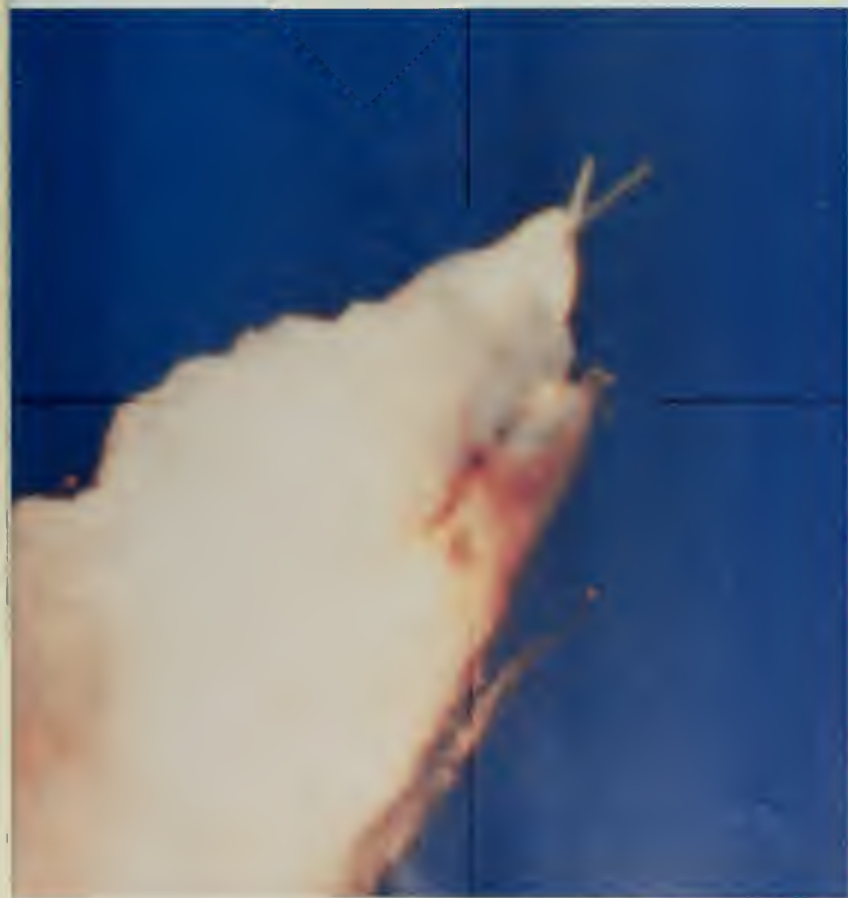
Structural breakup of the vehicle began at approximately 73 seconds. Fire spread very rapidly. Above, a bright flash (arrow) is evident near the nose of the Orbiter, suggesting spillage and ignition of the spacecraft's reaction control system propellants. At left, the two Solid Rocket Boosters thrust away from the fire, crisscrossing to form a "V." The right booster—identifiable by its failure plume—now to the left of its counterpart. At right, the External Tank wreckage is obscured by smoke and vapor. The Orbiter engines still firing, is visible at bottom center.

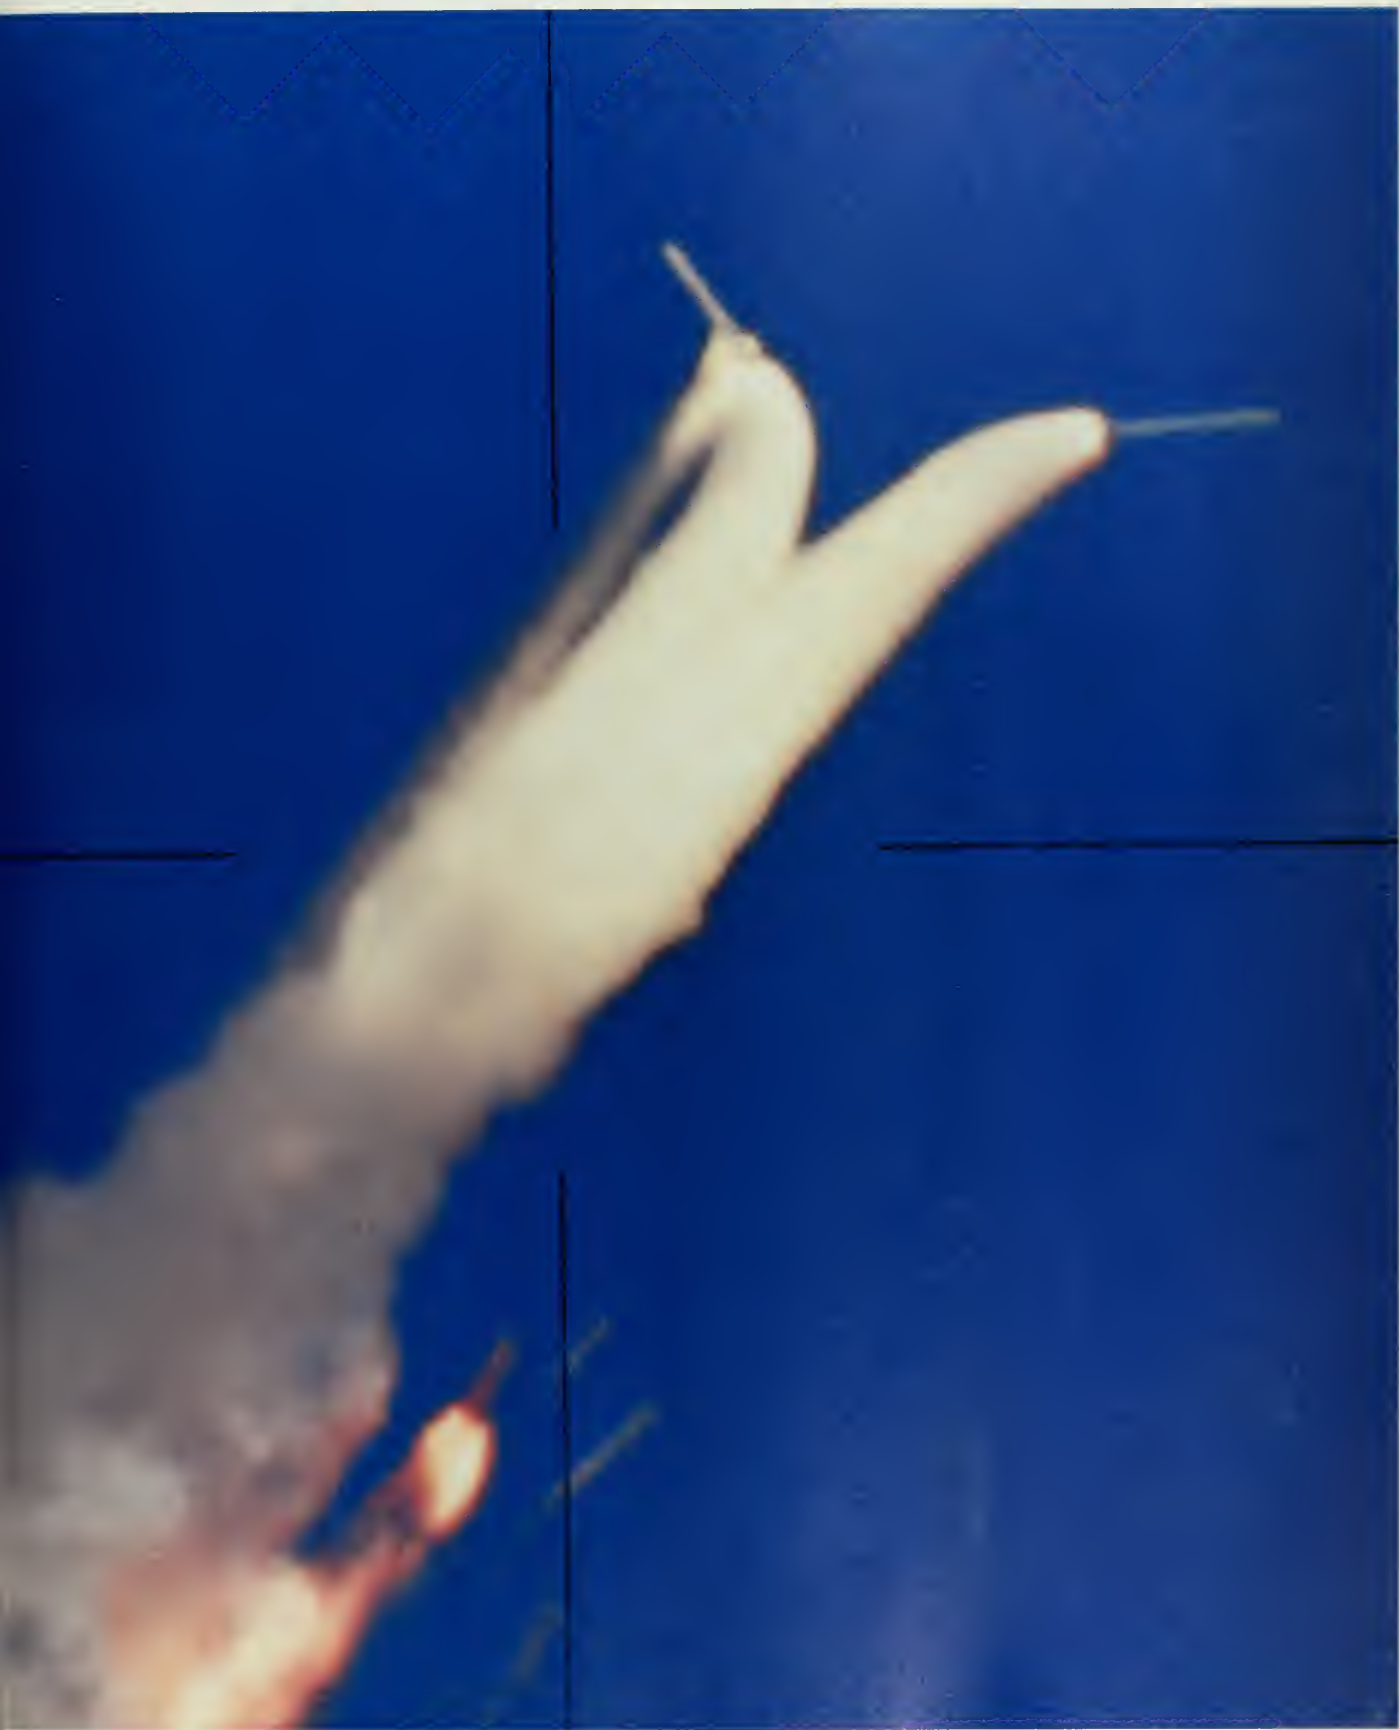
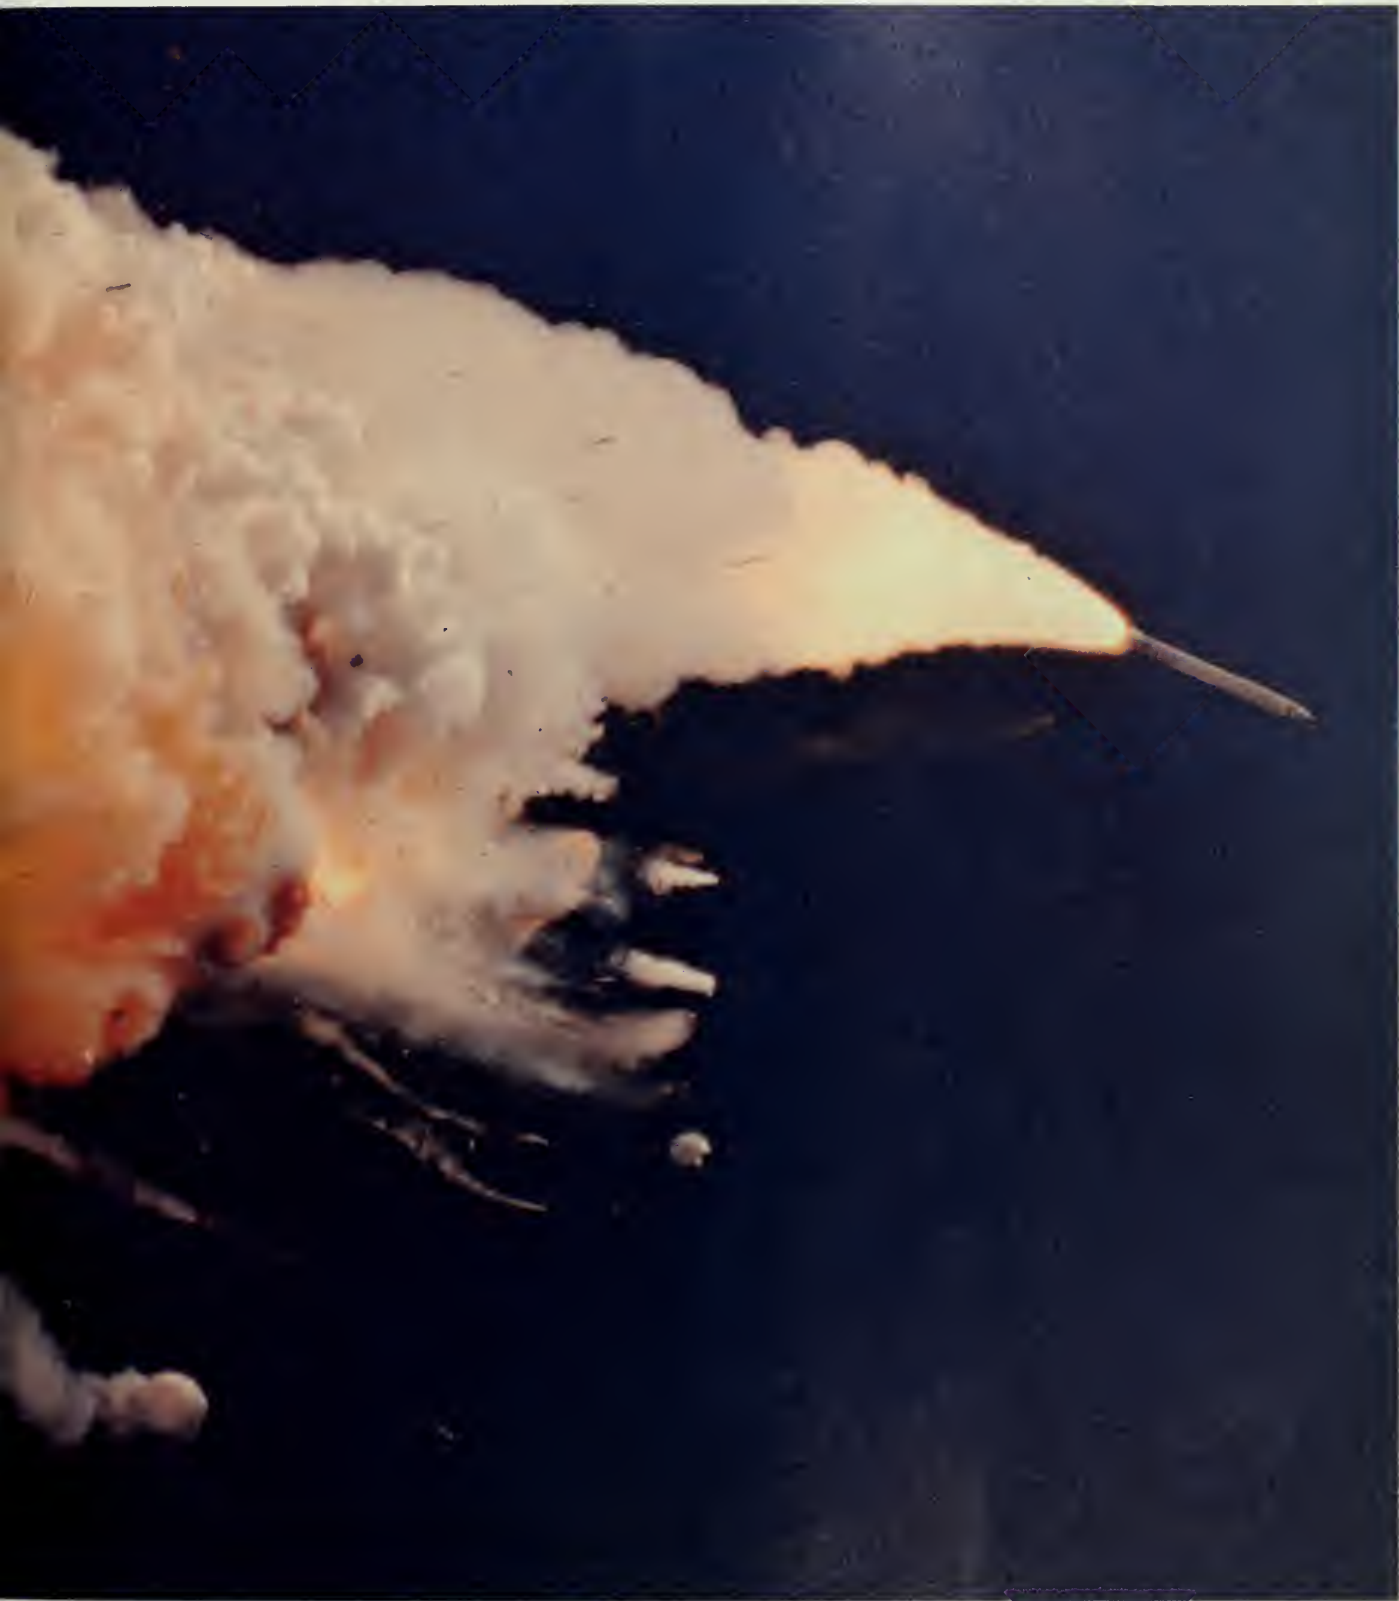
At about 76 seconds, unidentifiable fragments of the Shuttle vehicle can be seen tumbling against a background of fire, smoke and vaporized propellants from the External Tank (left). In the photo at right, the left booster (far right)

soars away, still thrusting. The reddish-brown cloud envelops the disintegrating Orbiter. The color is characteristic of the nitrogen tetroxide oxidizer in the Orbiter Reaction Control System propellant.

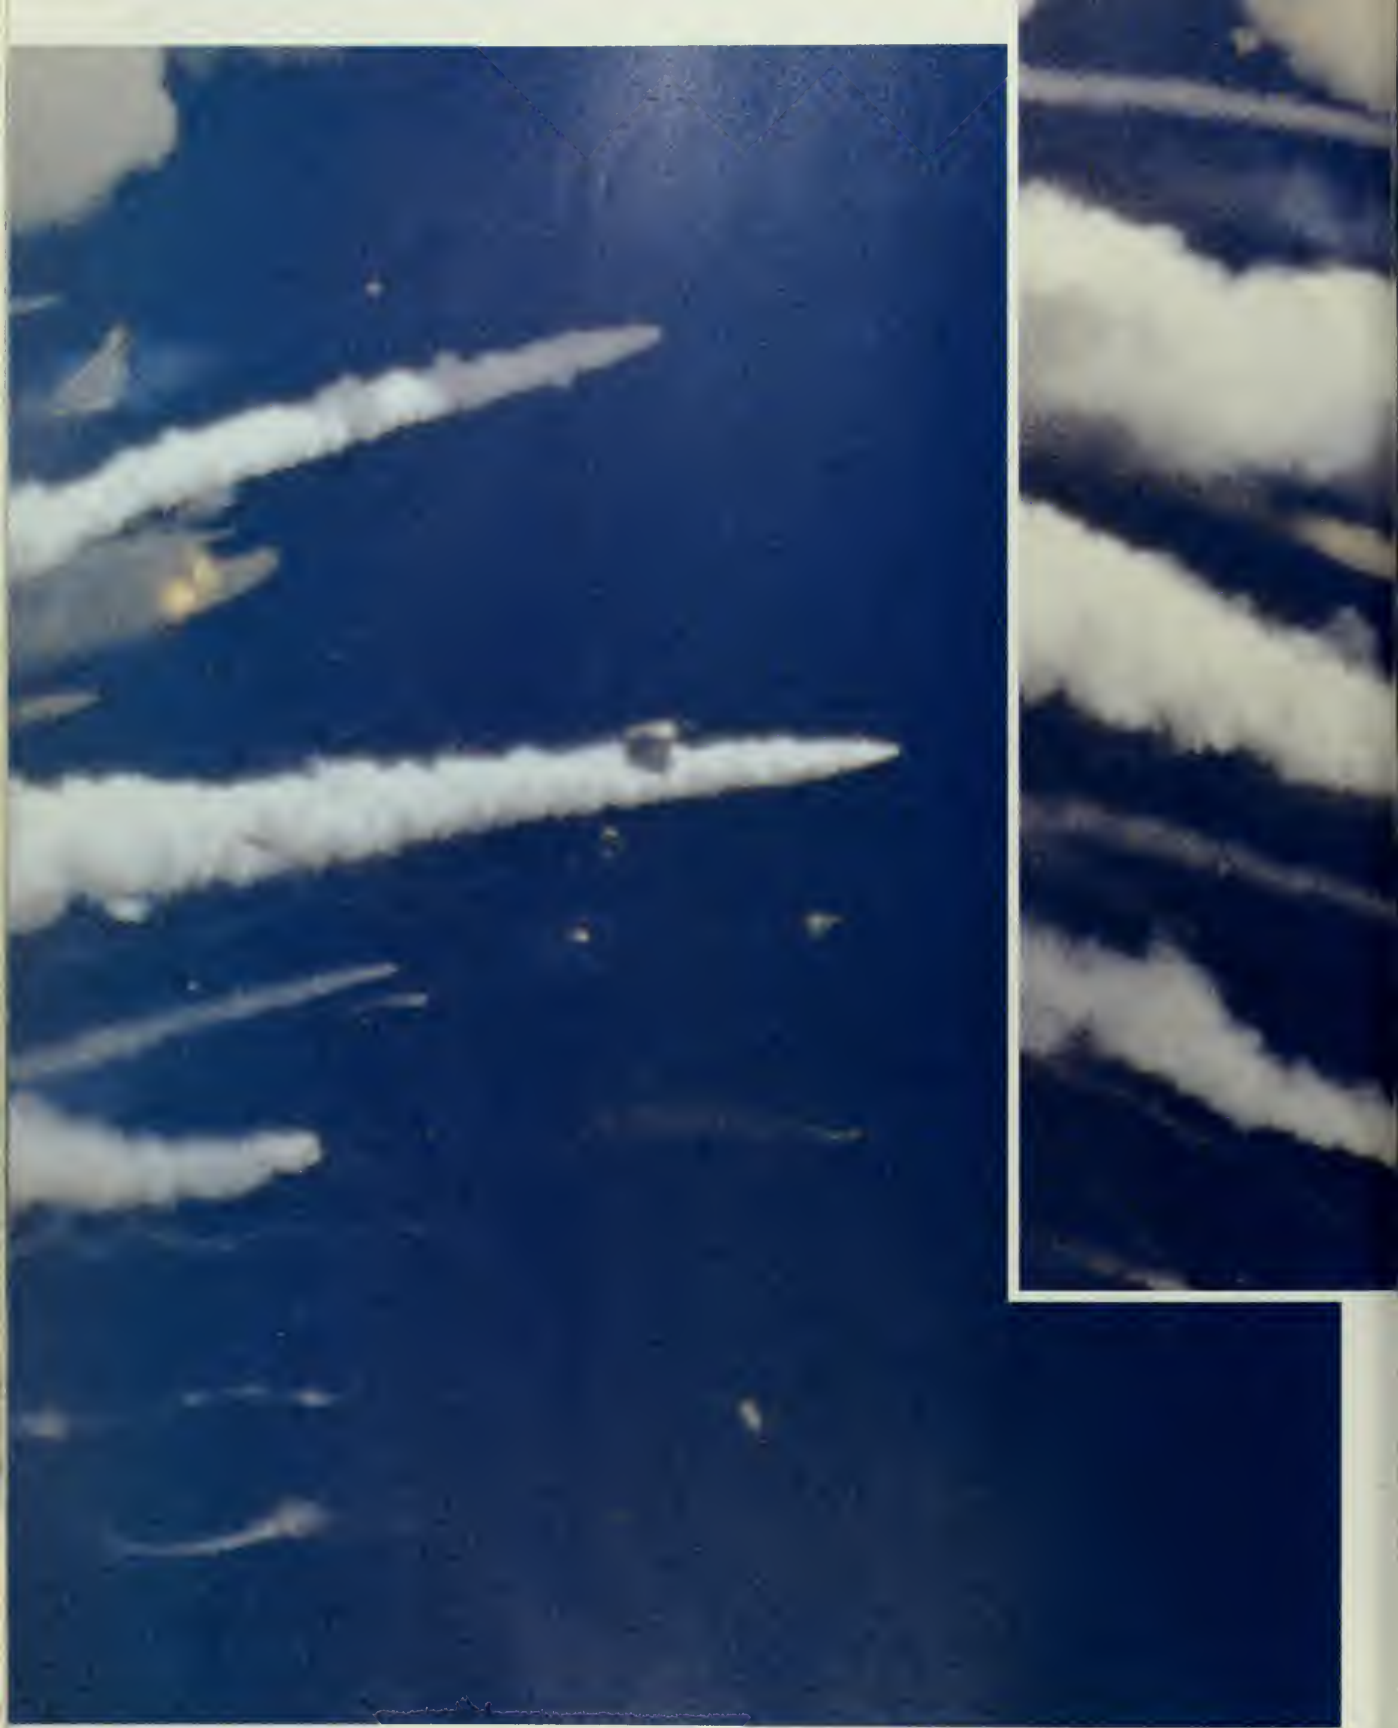
Hurling out of the fireball at 78 seconds (left) are the Orbiter's left wing (top arrow), the main engines (center arrow) and the forward fuselage (bottom arrow). In the photo below, it plunges Earthward, trailed by smoking fragments of Challenger.

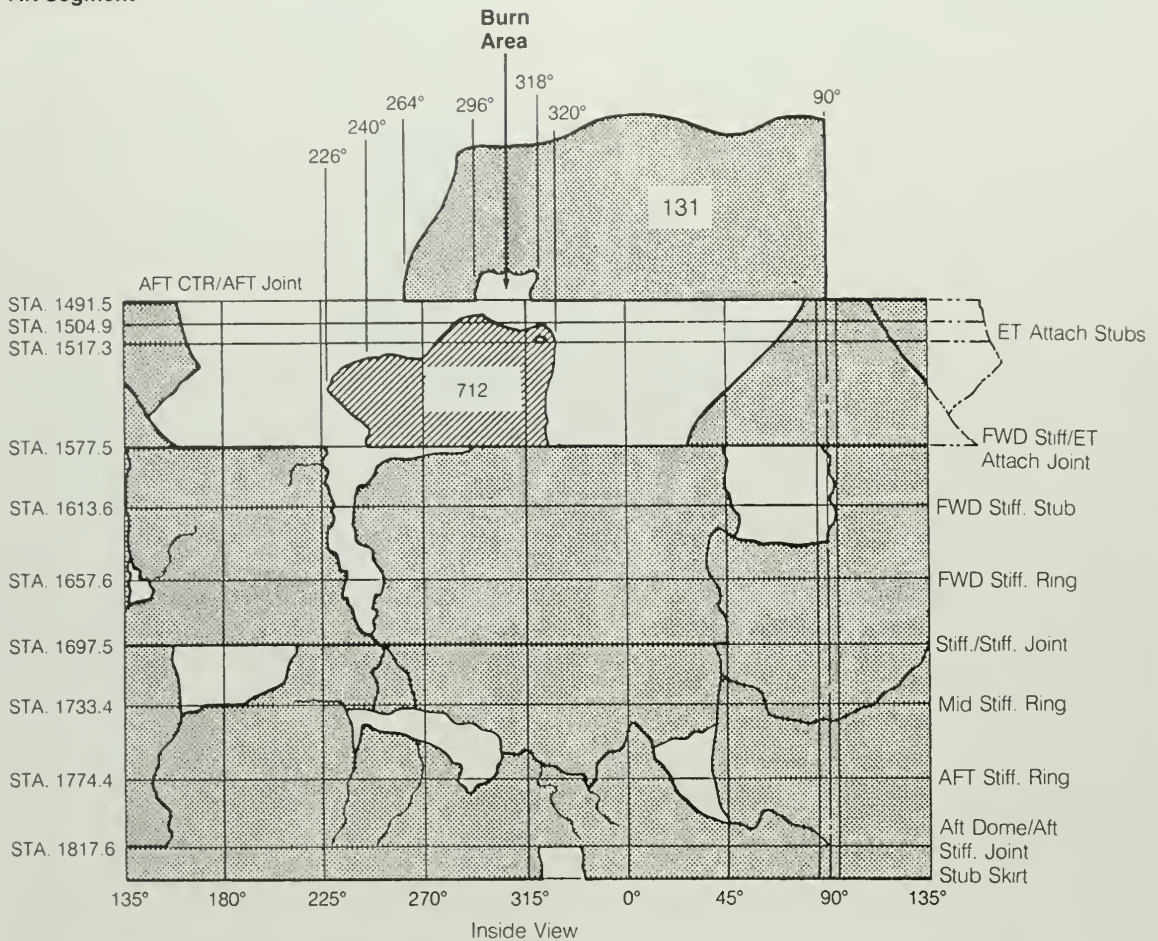
**RH SRB Recovered Debris  
Aft Segment**

Figure 25  
Drawing depicts pieces of right Solid Rocket Booster aft segment recovered. At top is piece of aft center segment.

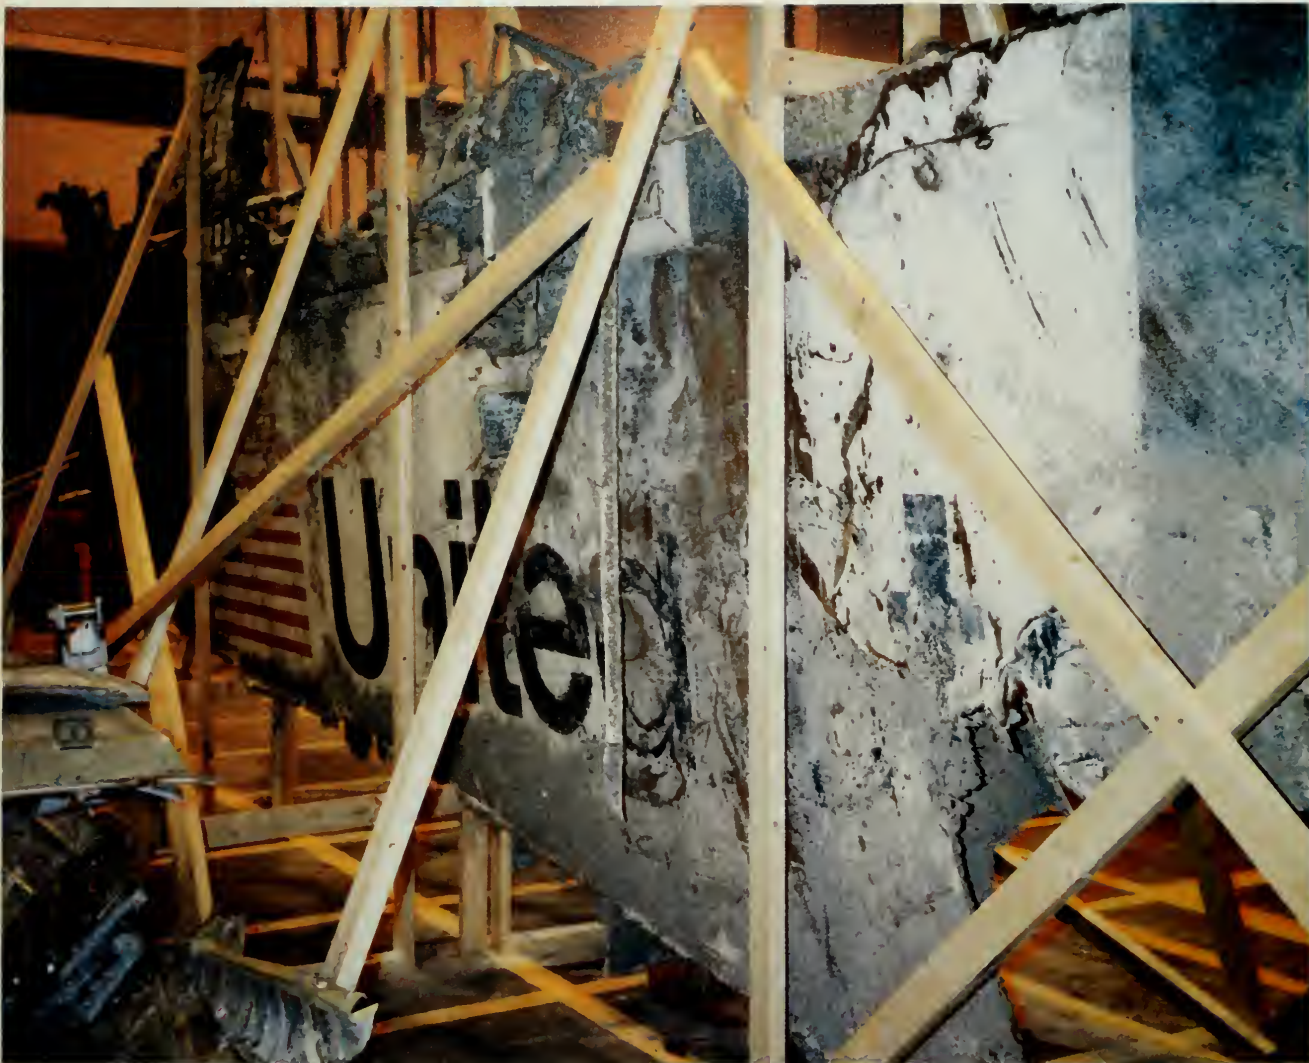
A The upper photos show, from left to right, the left side of the Orbiter (unburned), the right lower and upper rudder speed brake (both burn damaged) and left upper speed brake (unburned), confirmation that the fire was on the

right side of the Shuttle stack. The lower photos show the range safety destruct charges in the External Tank. These charges were exonerated when they were recovered intact and undetonated.

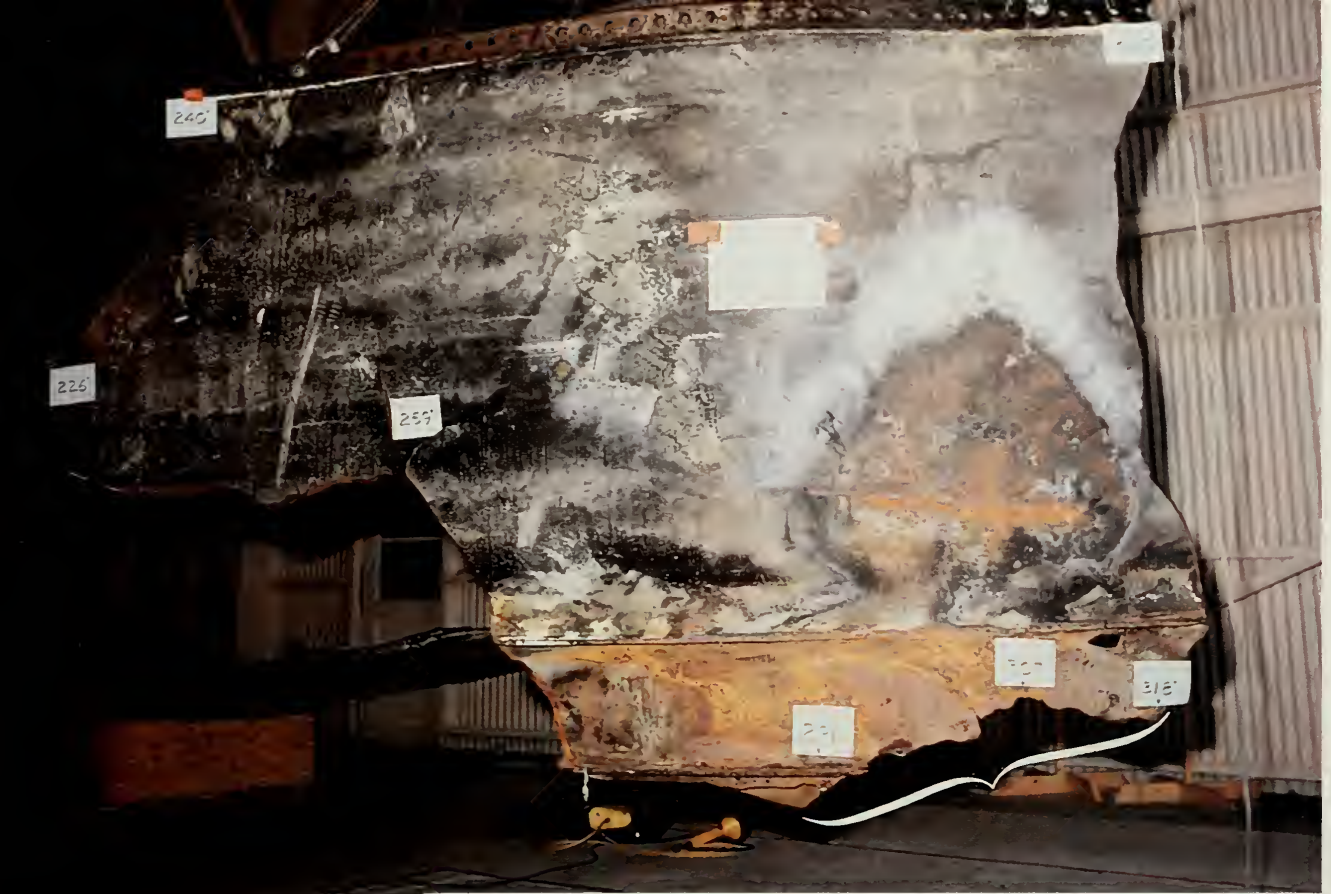
L

Examined at Kennedy Space Center after their recovery from the ocean, these fragments show the extent of burn through the right hand booster's aft field joint. On the left page are sections of the aft center motor segment above the joint. On the right page are sections (inverted) of the aft motor segment showing burn-hole below the joint (bracket). Except for the interior views on lower left, the camera is viewing the parts from outside the casing.

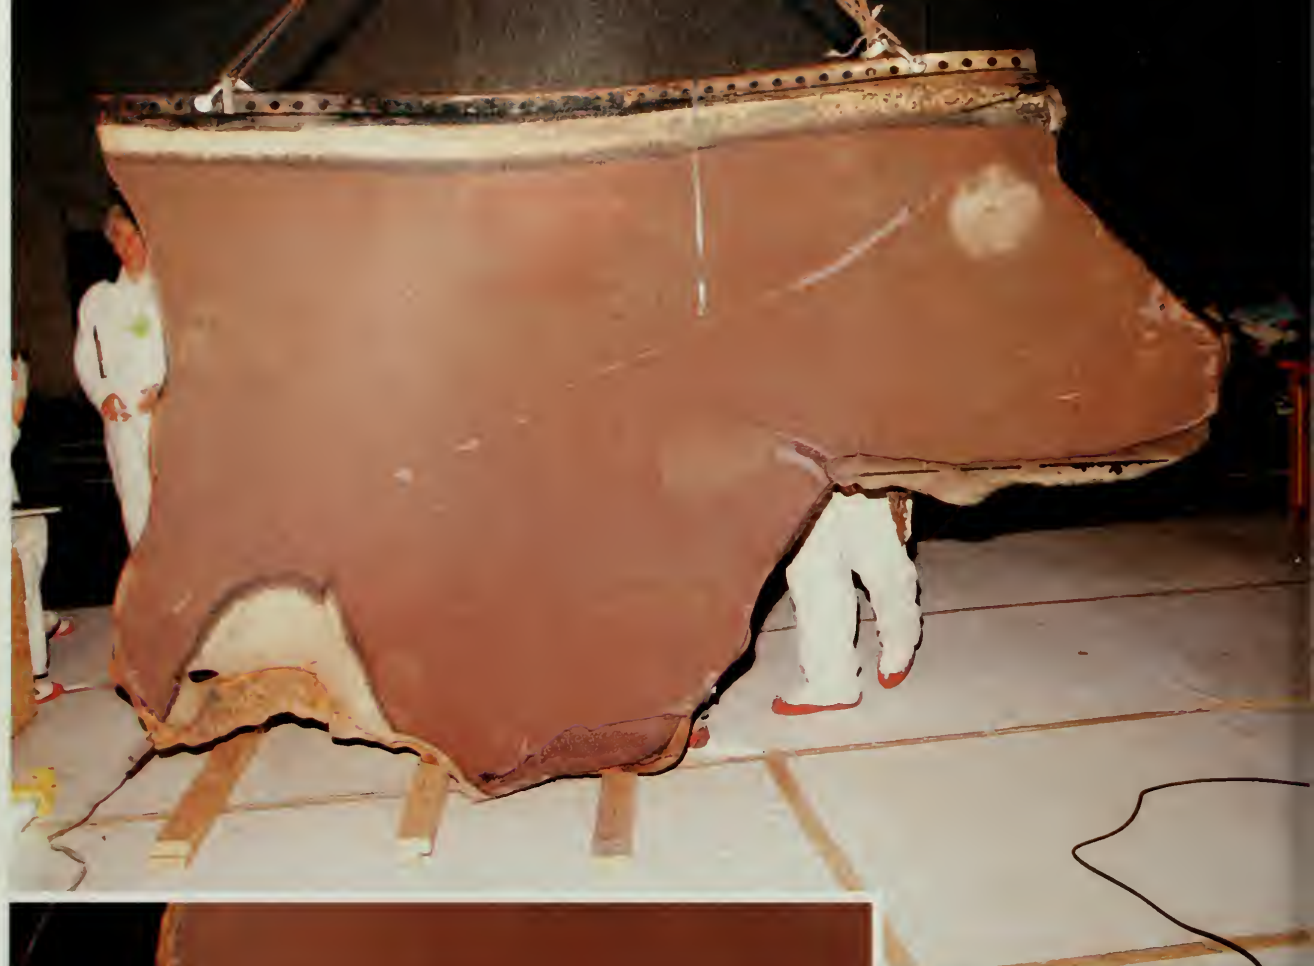
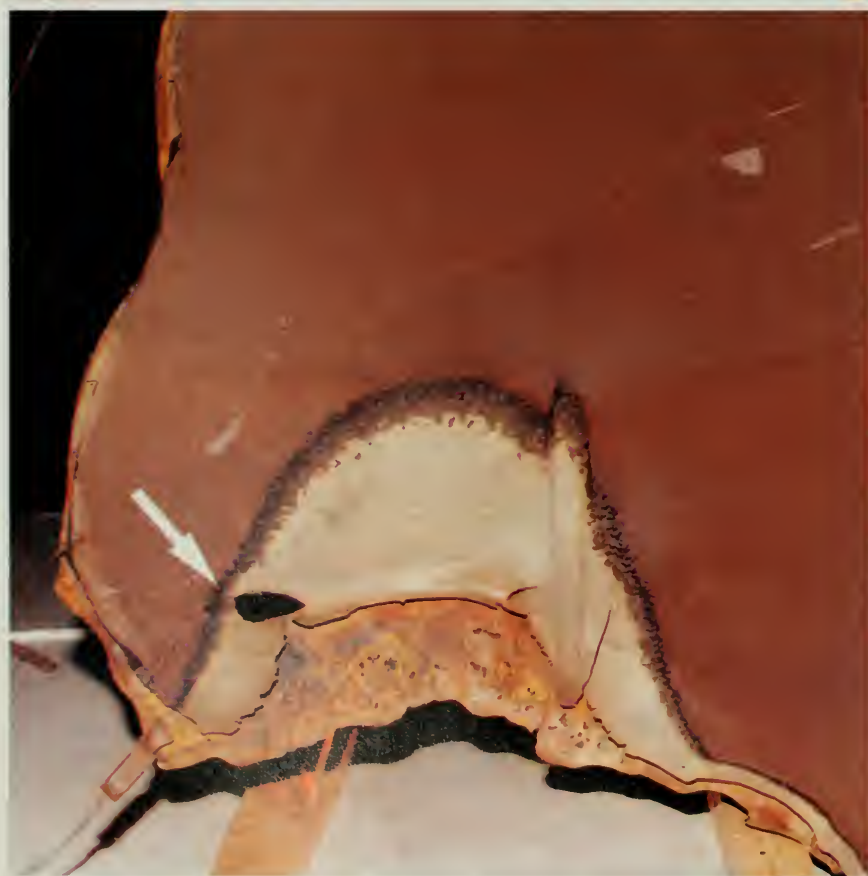
At upper left is the aft segment burn viewed from inside the casing; the lower photo is a closeup of the same section. The latter photo shows a hole (arrow) where the flame plume may have burned through the casing from the outside. At right is a composite view of the burn above and below the aft field joint.

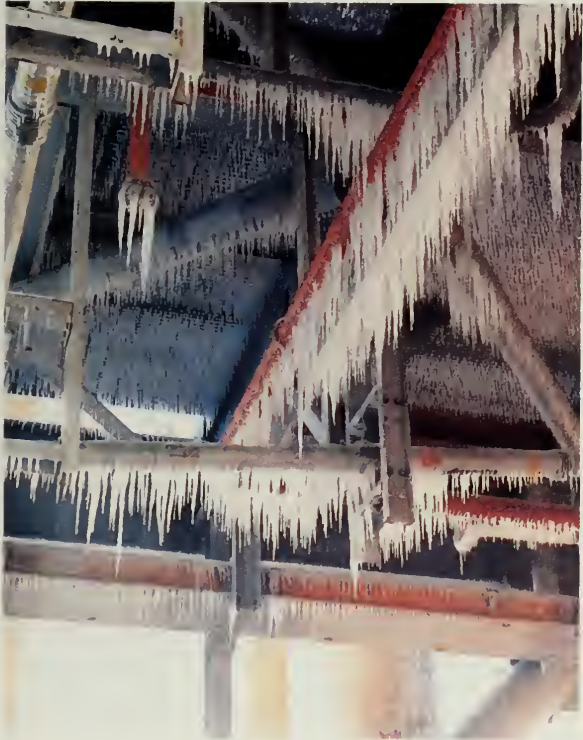
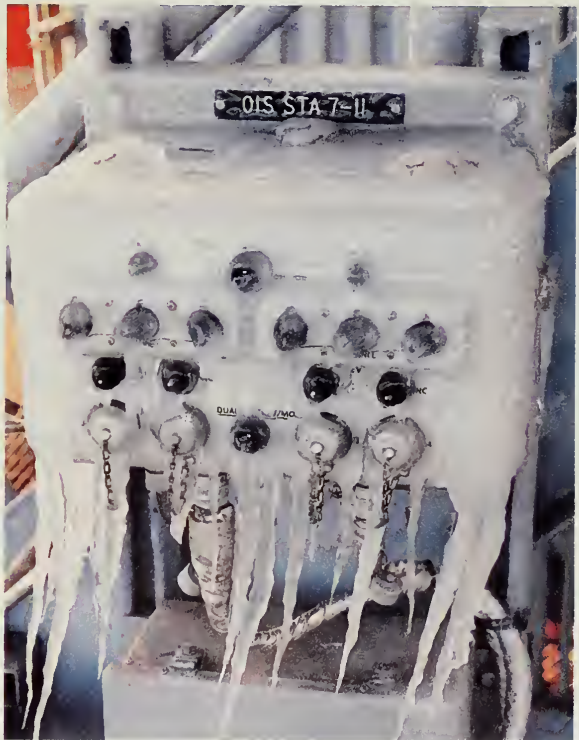
Above, foot long icicles on a lower level of the Fixed Service Structure frame the attachment point where the Orbiter is attached to the external tank (arrow). Icing was even more extensive at upper levels of the service structure (upper right and below). At right below is a ground communications box (not used during launch) rendered inoperable by heavy ice.
